WaterSignal detects cooling tower malfunction for Atlanta office

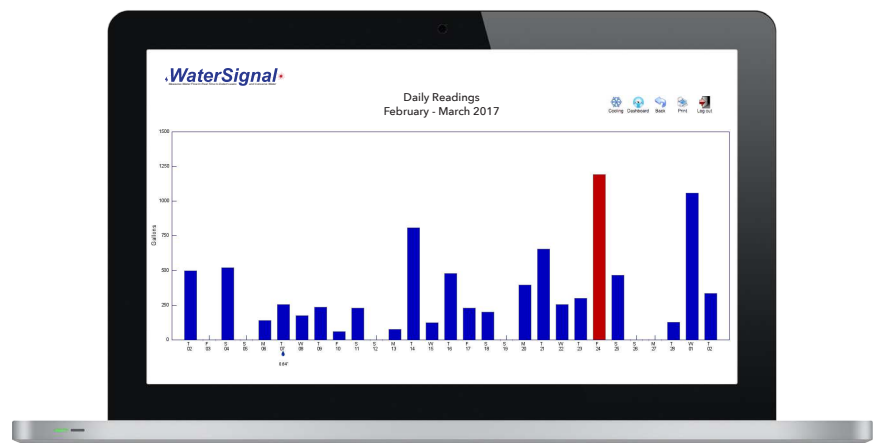
On February 28th and March 1st, WaterSignal detected that water usage had exceeded the daily alert level on the cooling tower blowdown.

Over a period of eight hours, the cooling tower blowdown wasted over 1,200 gallons; roughly 12% of the building's daily usage.

By drilling down to hourly graphs, managers were able to see excessive usage on the cooling tower blowdown after system shutdown. Upon inspection, the operations team discovered a blowdown malfunction that was allowing water to drain out.

- » Real time water monitoring provided instant access to hourly data trends
- » WaterSignal's 24/7 leak alerts quickly discovered the leak and alerted property management via SMS and email
- » A blowdown malfunction was discovered and repaired
- » Savings of \$485/month
