WaterSignal detects catastrophic irrigation leak for Texas office

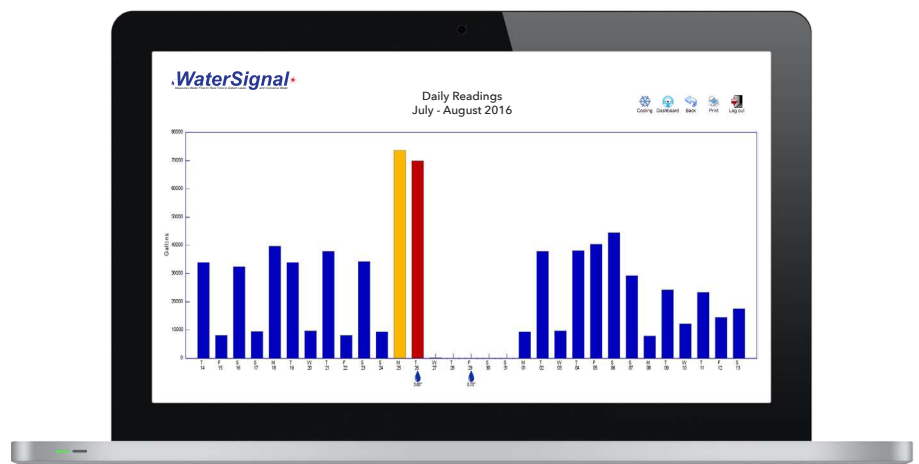
At 8:00pm on July 25th, WaterSignal alerted the property to excessive usage on the irrigation meter

Had the irrigation leak gone undetected, the property would have continued to use over 2.1 million gallons per month; that's almost 1.5 million gallons over the property's monthly average.

Following a reminder call from the WaterSignal account manager, property management quickly shut off to the irrigation system and found the leak.
